PASSAIC RIVER BASIN

### WOLF DEN DAM

PHASE I INSPECTION REPORT

NATIONAL DAM SAFETY PROGRAM

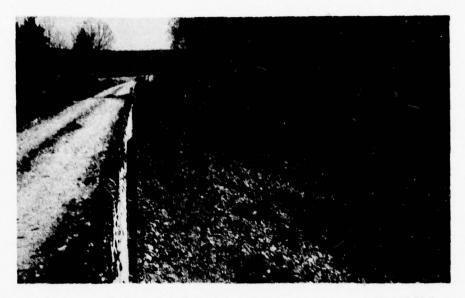
#### RECENTLY CLEARED SLOPE AREA

7.2.2 Operational and Maintenance Procedures: Tree removal must be continued to keep trees off the slopes. It is recommended that a periodic inspection program and a maintenance manual be prepared in the near future for this dam.

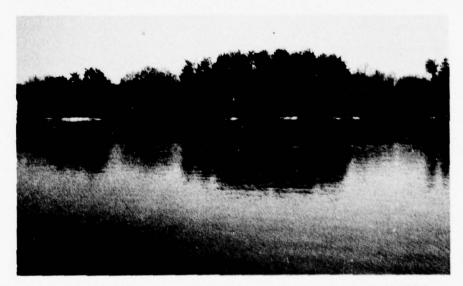
EASTERLY SEGMENTS OF DAM FILLING BETWEEN ROCK OUTCROPS
